**Preventive Maintenance Inspection
Thermographic Survey
For**

Sample Customer # 1

June 13, 2002

Infrared Inspection Report

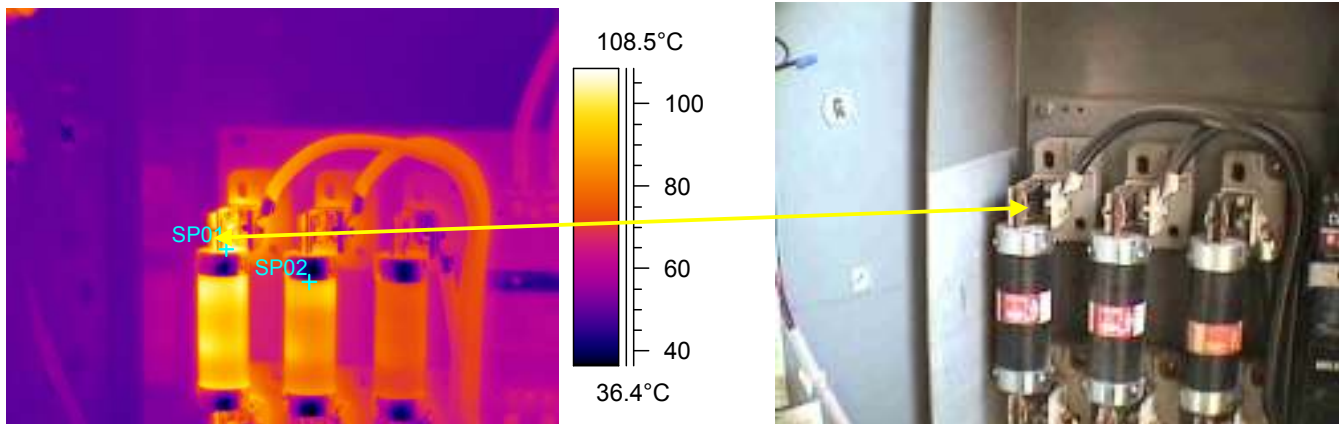
Date:	6/13/2002
Time:	7:10:45 AM
IR Scan Image File:	C0613-01.img
Location:	#4 Tape Wall
Equipment	Fuse Array
Component:	Fuse Clip
Maximum Temperature:	114.3°C
Minimum Temperature:	33.9°C
Differential Temperature:	64.3°C
Probable Cause:	Loose / dirty connection
*	*
Recommended Action:	Clean Connection and torque to proper specifications.

Clean Fuse Clip connections and fuse ends and reinstall fuses.

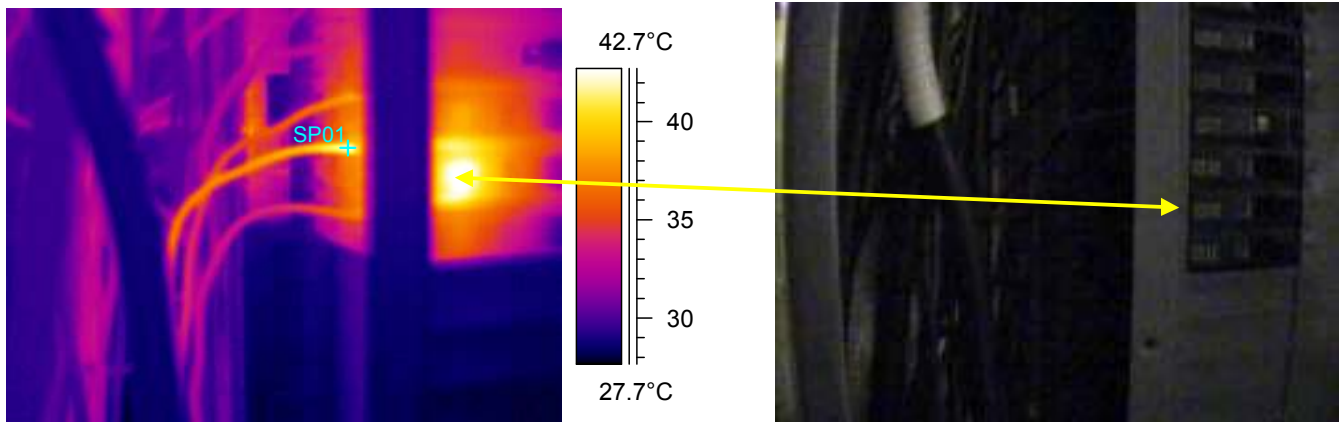
Date:	6/13/2002
Time:	7:26:17 AM
IR Scan Image File:	C0613-03.img
Location:	Warehouse
Equipment	200 amp panel
Component:	20 amp circuit breaker #12
Maximum Temperature:	44.0°C
Minimum Temperature:	27.4°C
Differential Temperature:	22.1°C
Probable Cause:	Overloaded circuit
*	*
Recommended Action:	Check loading and split load as needed

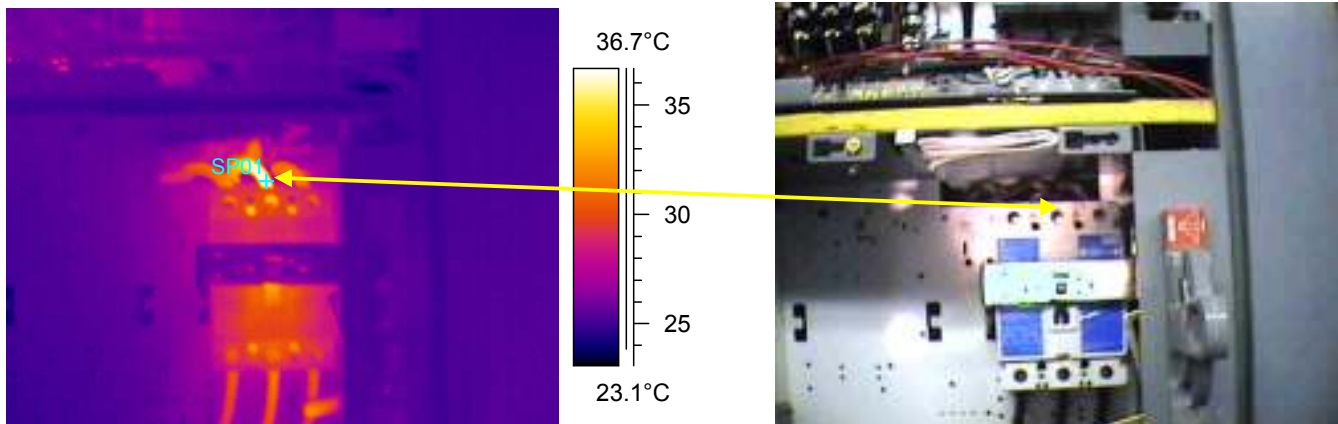
Date:	6/13/2002
Time:	8:48:19 AM
IR Scan Image File:	C0613-05.img
Location:	MCC 7300
Equipment	South Room MCC 7314
Component:	100 amp circuit breaker
Maximum Temperature:	37.5°C
Minimum Temperature:	23.7°C
Differential Temperature:	16.6°C
Probable Cause:	Loose / dirty connection
*	*
Recommended Action:	Clean Connection and torque to proper specifications.

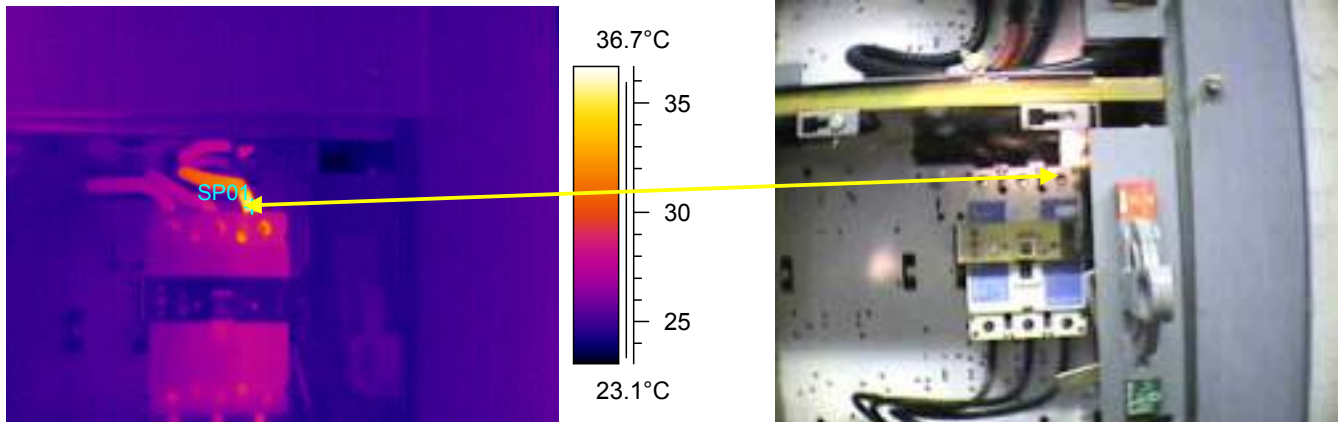
Date:	6/13/2002
Time:	8:50:55 AM
IR Scan Image File:	C0613-07.img
Location:	MCC 7300
Equipment	#2 Rewinder MCC 7316
Component:	100 amp breaker connection
Maximum Temperature:	36.5°C
Minimum Temperature:	23.3°C
Differential Temperature:	15.7°C
Probable Cause:	Loose / dirty connection
*	*
Recommended Action:	Clean Connection and torque to proper specifications.

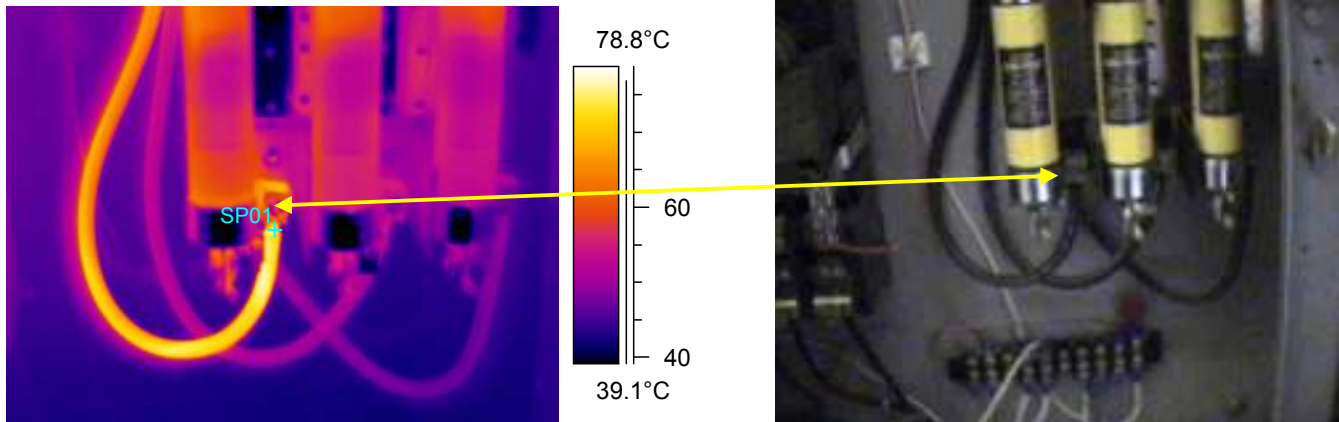
Date:	6/13/2002
Time:	9:15:48 AM
IR Scan Image File:	C0613-09.img
Location:	North MCC Room
Equipment	#2 Waxer Disconnect
Component:	Load side fuse cable connection
Maximum Temperature:	77.5°C
Minimum Temperature:	36.9°C
Differential Temperature:	56.7°C
Probable Cause:	Loose / dirty connection
*	*
Recommended Action:	Clean Connection and torque to proper specifications.

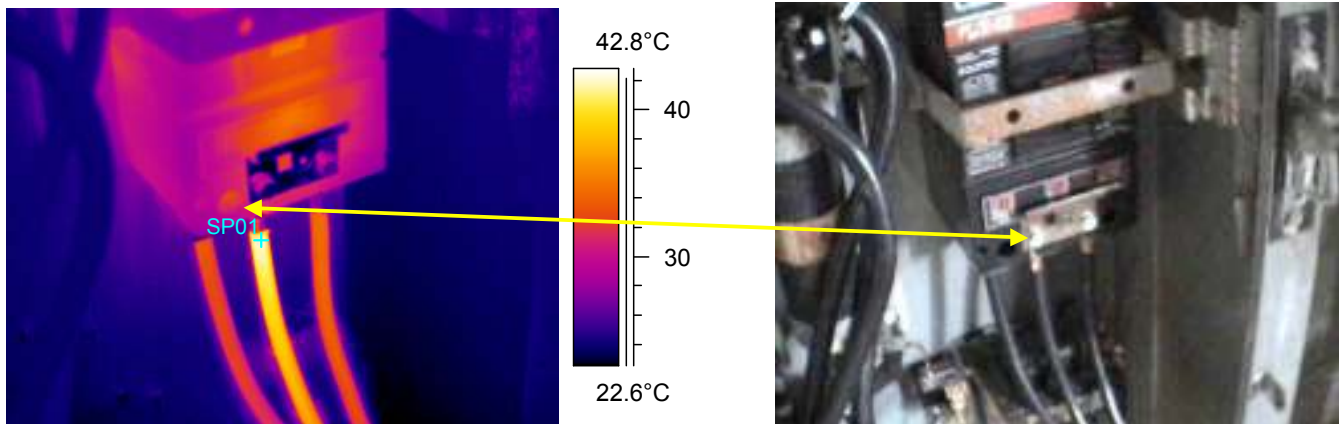
Date:	6/13/2002
Time:	11:53:55 AM
IR Scan Image File:	C0613-13.img
Location:	Feed Pump House
Equipment	400 amp main disconnect
Component:	Load side cable connection
Maximum Temperature:	42.4°C
Minimum Temperature:	21.9°C
Differential Temperature:	21.6°C
Probable Cause:	Loose / dirty connection
*	*
Recommended Action:	Clean Connection and torque to proper specifications.

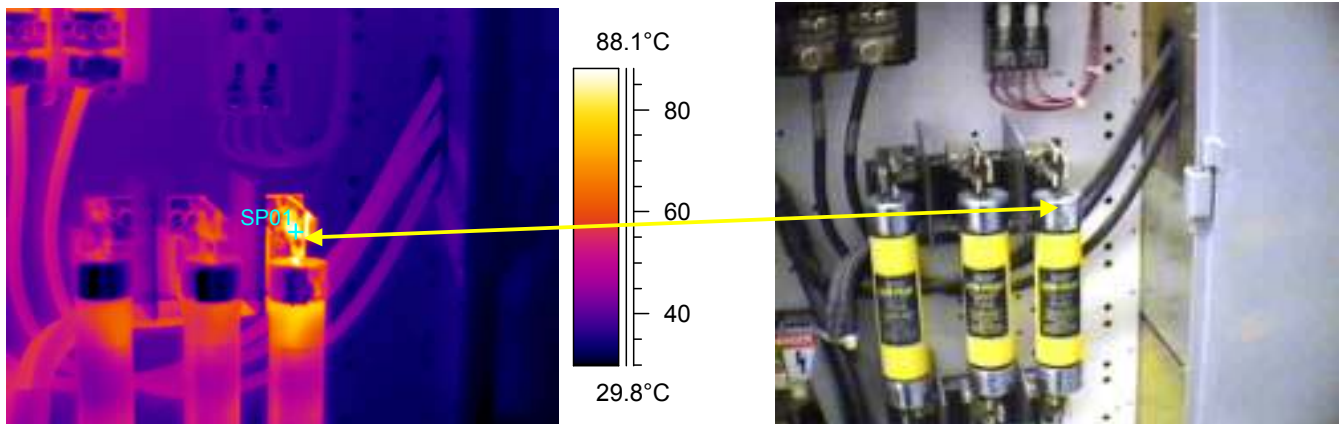
Date:	6/13/2002
Time:	12:27:54 PM
IR Scan Image File:	C0613-19.img
Location:	MCC 45
Equipment	80 amp fused disconnect
Component:	Fuse clip connection
Maximum Temperature:	93.6°C
Minimum Temperature:	28.1°C
Differential Temperature:	72.8°C
Probable Cause:	Loose / dirty connection
*	*
Recommended Action:	Clean Connection and torque to proper specifications.

Clean Fuse Clip connections and fuse ends and reinstall fuses.

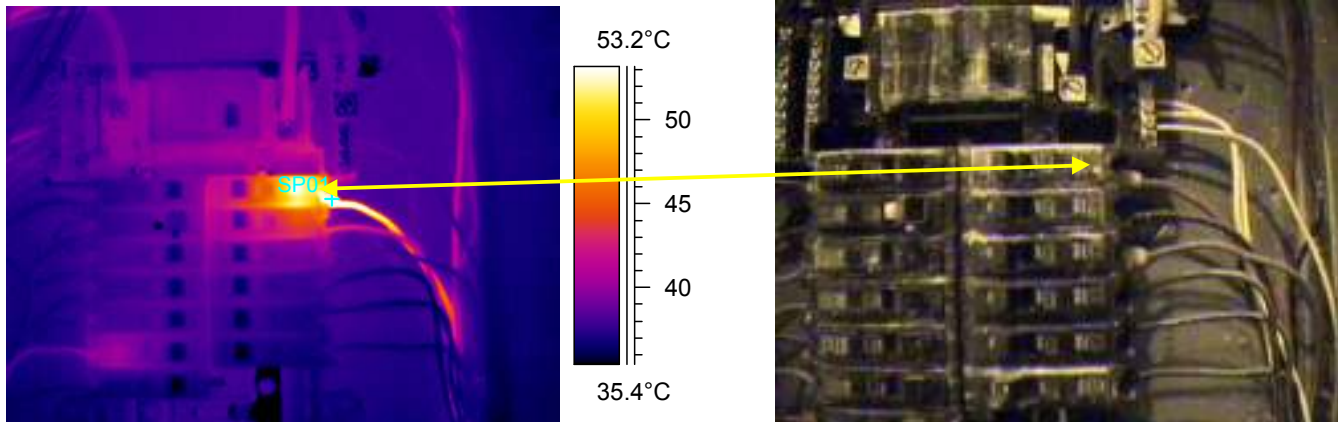
Date:	6/14/2002
Time:	12:43:16 PM
IR Scan Image File:	C0614-47.img
Location:	South Wall Box 20
Equipment	#20 computer room
Component:	20 amp circuit breaker
Maximum Temperature:	62.2°C
Minimum Temperature:	33.6°C
Differential Temperature:	41.4°C
Probable Cause:	Loose / dirty connection
*	*
Recommended Action:	Clean Connection and torque to proper specifications.
