**Preventive Maintenance Inspection
Thermographic Survey
For**

Sample Customer #2

May 28, 2002

Infrared Inspection Report

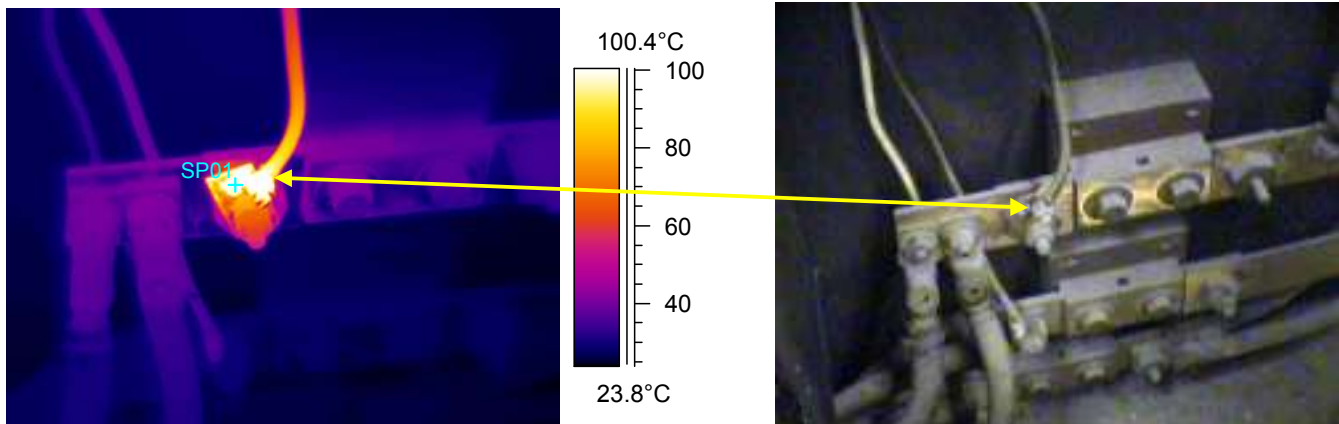
Date: 5/28/2002
Time: 6:37:32 AM
IR Scan Image File: C0528-01.img
Location: Distribution Area
Equipment: Main 240 volt feed
Component: Load side cable top phase
Maximum Temperature: 153.7°C
Minimum Temperature: 24.2°C
Differential Temperature: 132.9°C
Probable Cause: Loose / dirty connection

Recommended Action: Clean Connection and torque to proper specifications.

Disassemble connection clean well and re-assemble using joint compound. Tighten and torque to proper specifications.

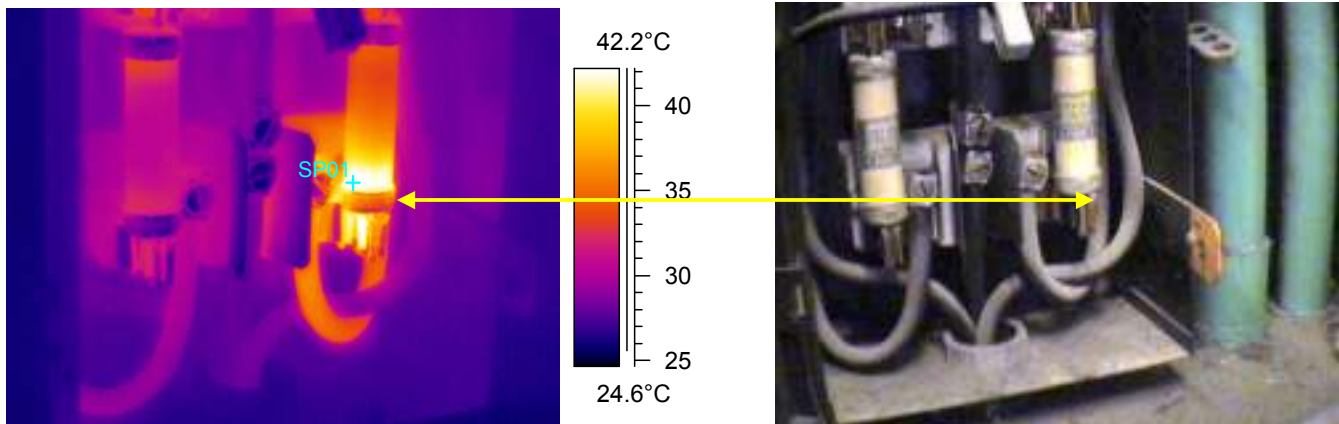
Date: 5/28/2002
Time: 6:41:58 AM
IR Scan Image File: C0528-03.img
Location: Distribution Area
Equipment: West Door Disconnect
Component: Load side lower right fuse clip
Maximum Temperature: 42.7°C
Minimum Temperature: 25.5°C
Differential Temperature: 21.8°C
Probable Cause: Loose / dirty connection

Recommended Action: Clean Connection.

Clean connection and fuse clip.

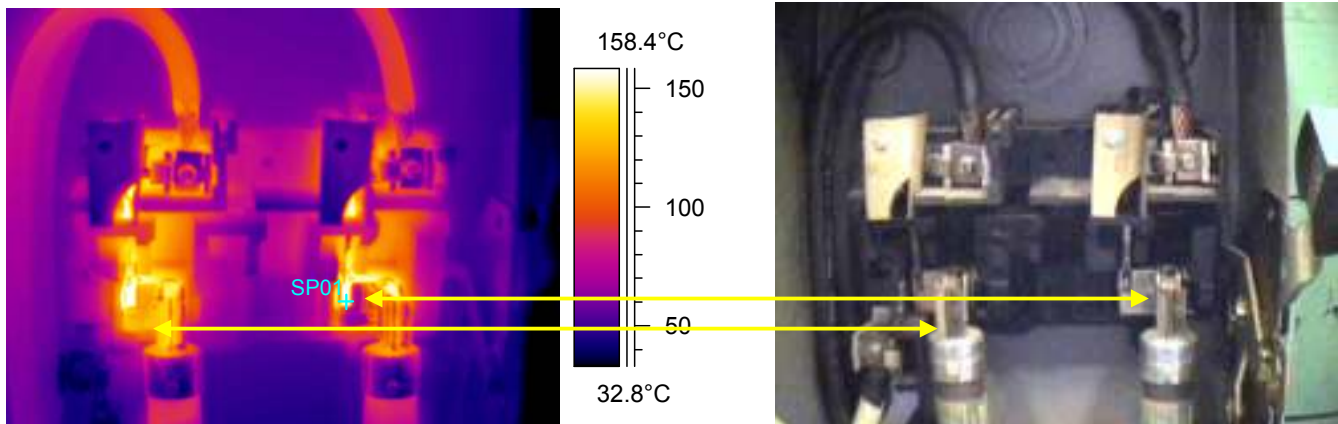
Date: 5/28/2002
Time: 6:44:22 AM
IR Scan Image File: C0528-05.img
Location: Distribution Area
Equipment: Machining Sander
Component: Upper knife blades & fuse clips
Maximum Temperature: 166.5°C
Minimum Temperature: 28.6°C
Differential Temperature: 142.4°C
Probable Cause: Loose / dirty connection

Recommended Action: Clean Connections

Clean knife blades and fuse clips as needed.

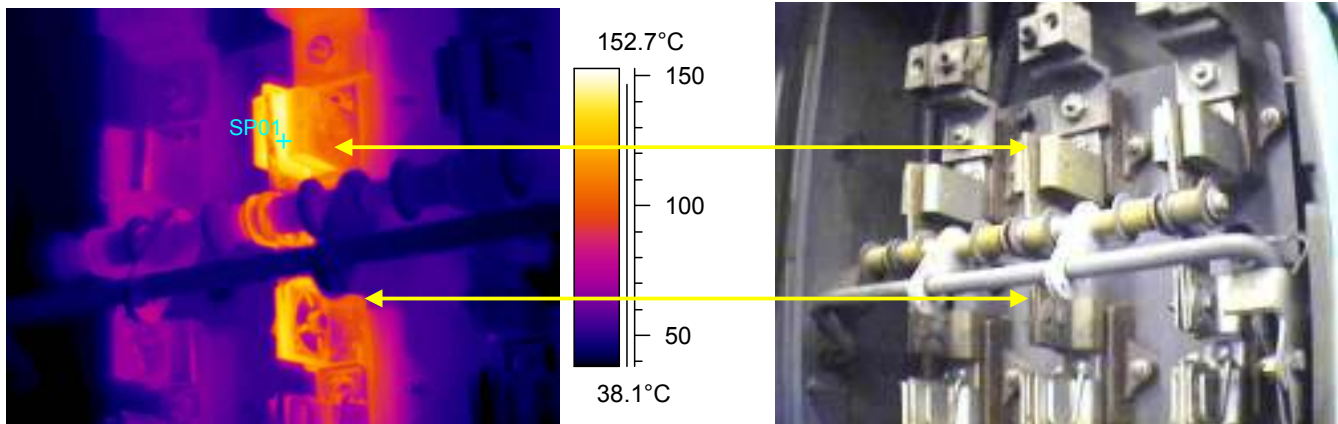
Date: 5/28/2002
Time: 6:50:32 AM
IR Scan Image File: C0528-07.img
Location: Main Distribution
Equipment: 250 Amp Main
Component: Center Phase main blade & hinge
Maximum Temperature: 147.9°C
Minimum Temperature: 33.4°C
Differential Temperature: 124.3°C
Probable Cause: Loose / dirty connection

Recommended Action: Clean Connection and replace parts as needed.

Clean main blade and hinge or replace as needed.

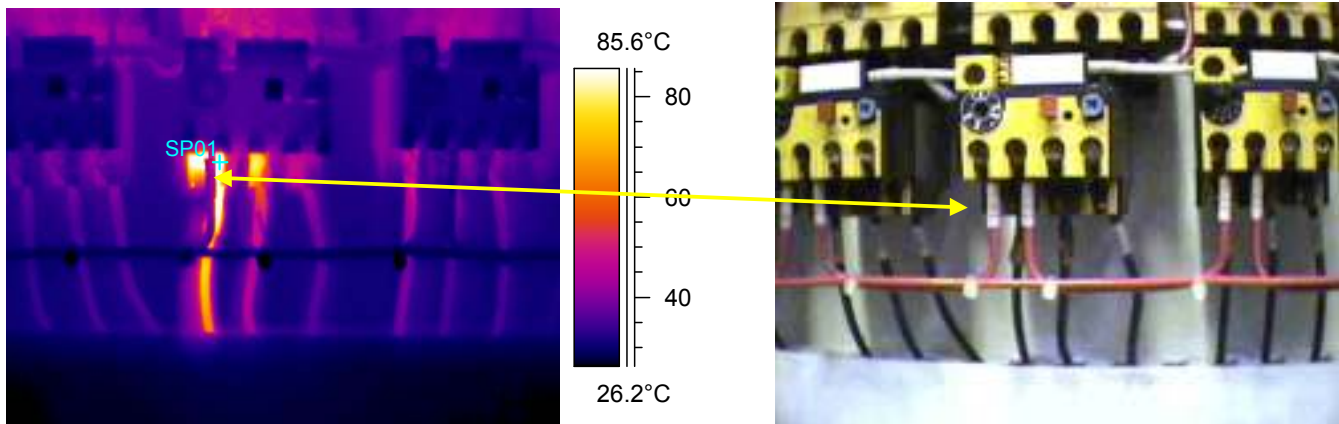
Date: 5/28/2002
Time: 7:03:09 AM
IR Scan Image File: C0528-09.img
Location: Generator Area
Equipment: WO1 Contactor 4M
Component: Overload block
Maximum Temperature: >174.0°C
Minimum Temperature: 24.3°C
Differential Temperature: >153.1°C
Probable Cause: Loose / dirty connection

Recommended Action: Clean Connection and torque to proper specifications.

Clean Cable connections and re-install.

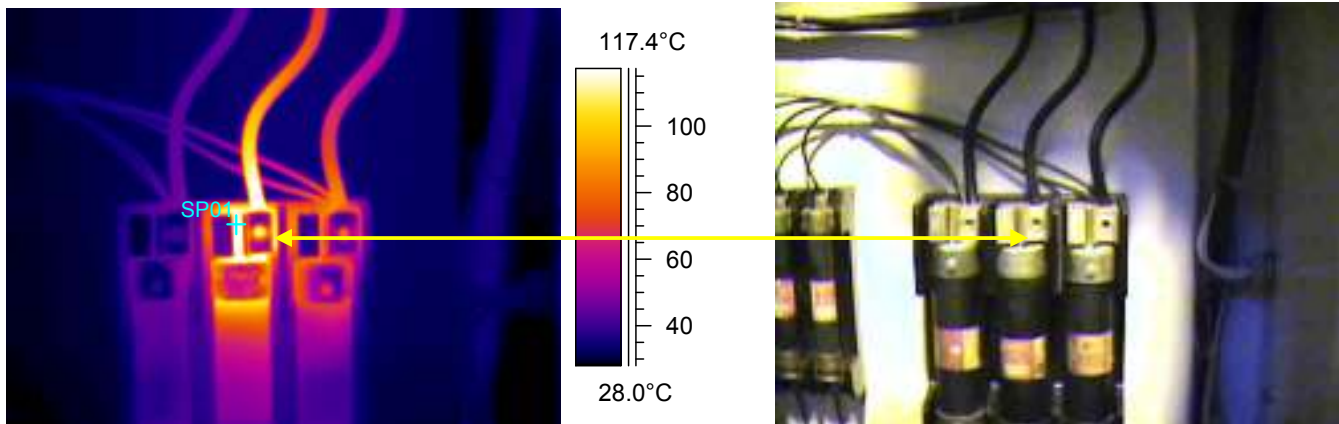
Date: 5/28/2002
Time: 7:11:45 AM
IR Scan Image File: C0528-11.img
Location: Foundry Area
Equipment: B14 Control Cabinet
Component: 80 amp fuse array - fuse clip
Maximum Temperature: 144.3°C
Minimum Temperature: 26.5°C
Differential Temperature: 123.4°C
Probable Cause: Loose / dirty connection

Recommended Action: Clean Connection and torque to proper specifications.

Disassemble fuse clip and wire connection clean and re-connect.

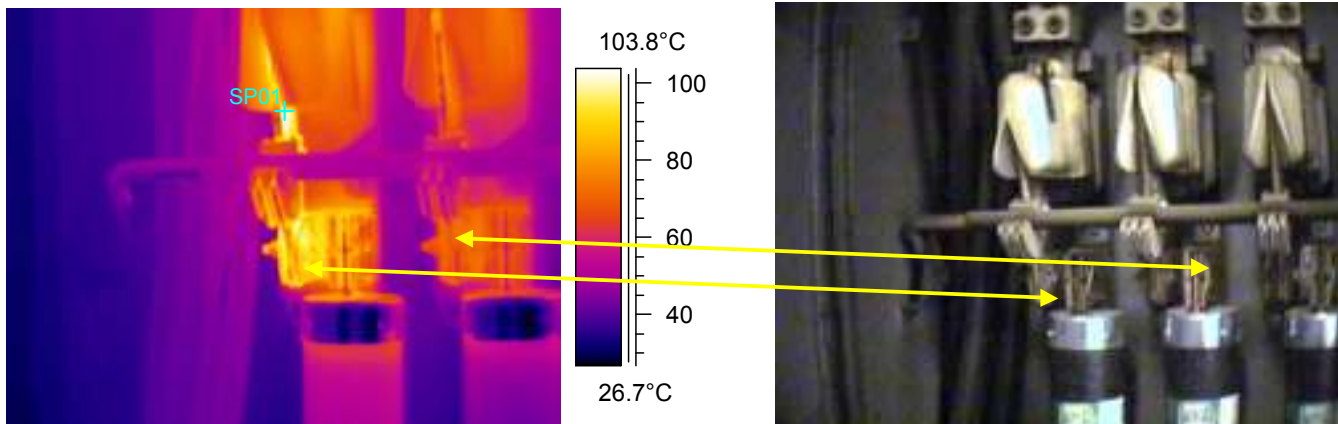
Date: 5/28/2002
Time: 7:31:13 AM
IR Scan Image File: C0528-13.img
Location: South Distribution
Equipment: 600 amp Disconnect
Component: Left & Center fuse clip & knife blades
Maximum Temperature: 105.0°C
Minimum Temperature: 27.3°C
Differential Temperature: 84.1°C
Probable Cause: Loose / dirty connection

Recommended Action: Clean Connection re-assemble

Clean fuse clips and knife blades as needed.

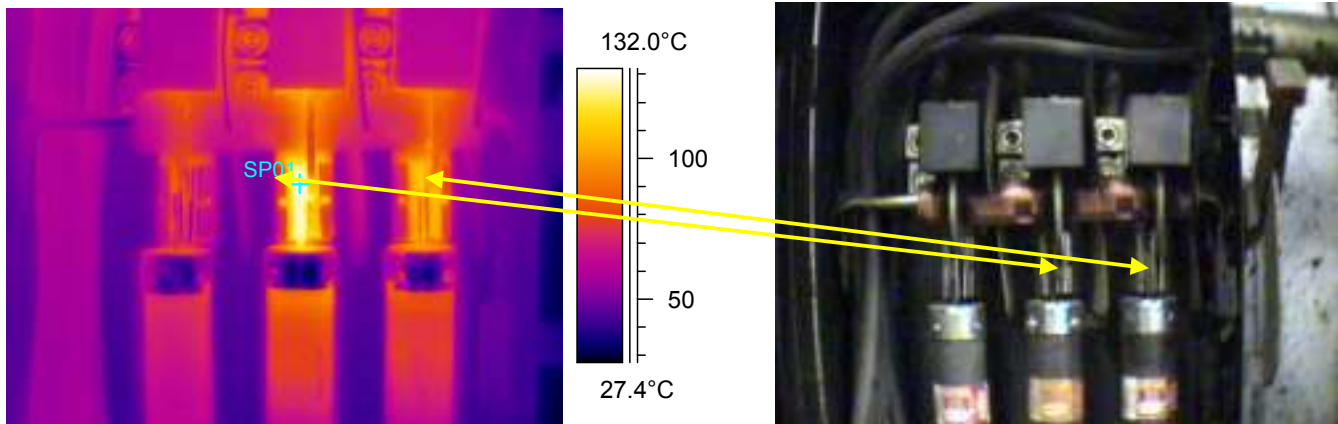
Date: 5/28/2002
Time: 7:34:17 AM
IR Scan Image File: C0528-15.img
Location: South Distribution
Equipment: 200 Amp Disconnect
Component: Right and center knife blade & fuse clips
Maximum Temperature: 134.0°C
Minimum Temperature: 27.2°C
Differential Temperature: 113.1°C
Probable Cause: Loose / dirty connection

Recommended Action: Clean Connection and torque to proper specifications.

Clean knife blades and fuse clip connections.

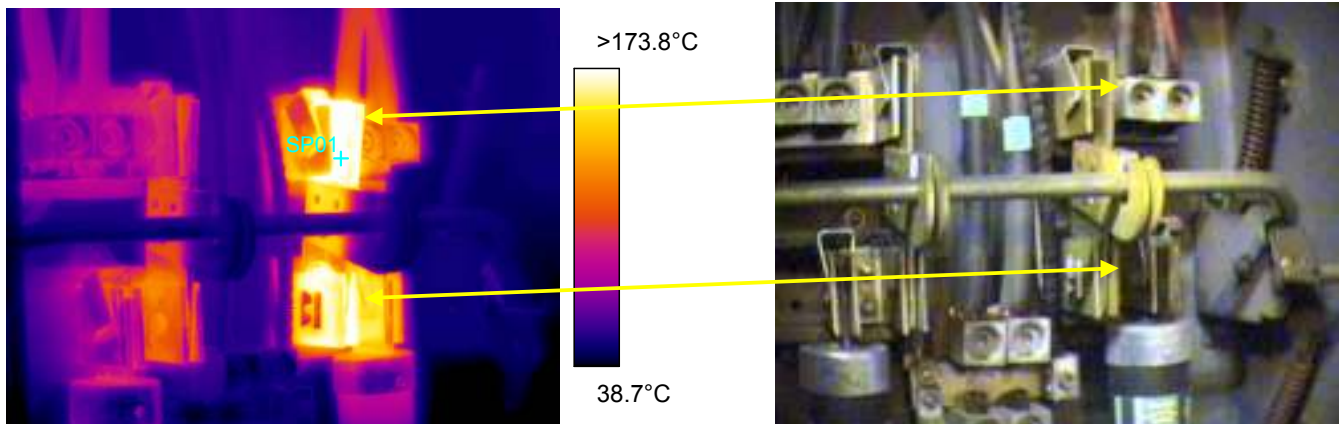
Date: 5/28/2002
Time: 8:14:44 AM
IR Scan Image File: C0528-17.img
Location: Distribution Area
Equipment: 600 Amp Main
Component: Right phase connection & blade
Maximum Temperature: >173.8°C
Minimum Temperature: 35.1°C
Differential Temperature: >152.9°C
Probable Cause: Blade not installed correct

Recommended Action: Clean Connection and torque to proper specifications.

Claen Blade and connection areas, make sure that the blade is all the way in when closed.

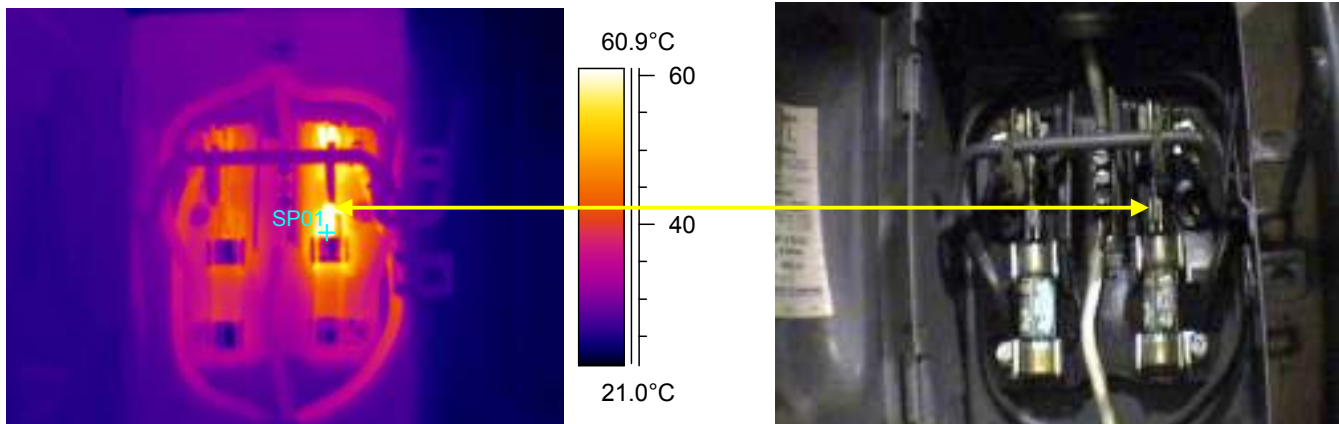
Date: 5/28/2002
Time: 8:57:56 AM
IR Scan Image File: C0528-19.img
Location: Warehouse
Equipment: 30 Amp Power TFX
Component: Right knife blade & fuse clip
Maximum Temperature: 67.1°C
Minimum Temperature: 21.1°C
Differential Temperature: 46.3°C
Probable Cause: Loose / dirty connection

Recommended Action: Clean Connection and torque to proper specifications.

Clean knife blade and fuse clips, replace parts as needed.

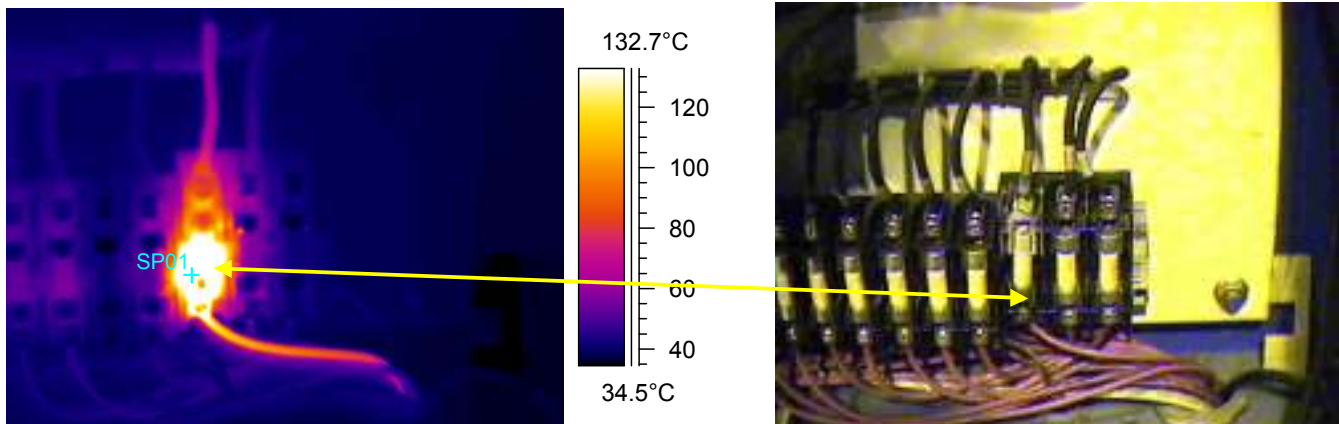
Date: 5/28/2002
Time: 9:04:16 AM
IR Scan Image File: C0528-21.img
Location: Holding Controls
Equipment: Machine C11 - 30 Amp
Component: Left phase bottom fuse clip
Maximum Temperature: >174.0°C
Minimum Temperature: 34.0°C
Differential Temperature: >153.2°C
Probable Cause: Loose / dirty connection

Recommended Action: Clean Connection and torque to proper specifications.

Replace bottom fuse clip.

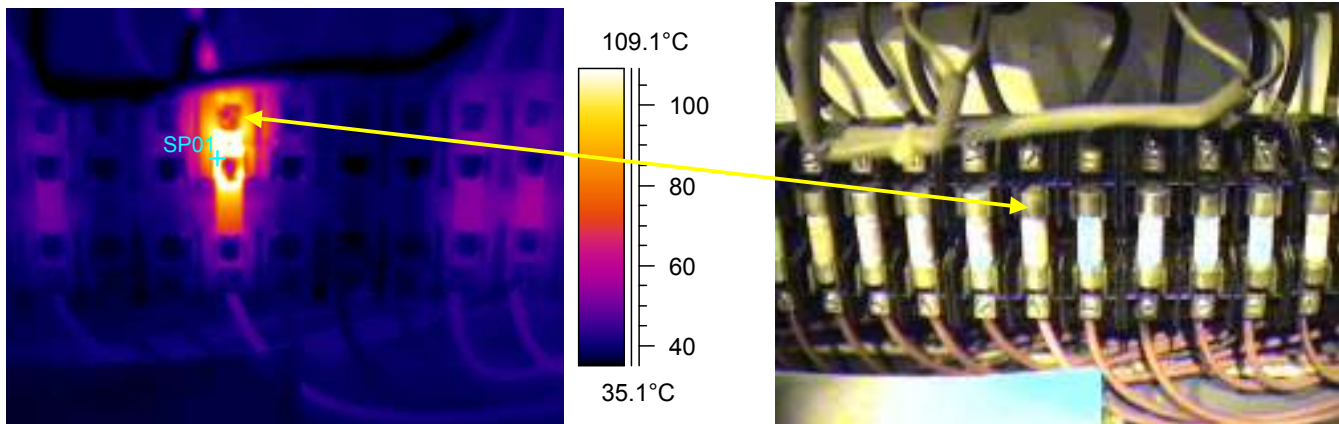
Date: 5/28/2002
Time: 9:06:28 AM
IR Scan Image File: C0528-23.img
Location: Holding Control
Equipment: Holding Pot C11
Component: 30 amp fuse array
Maximum Temperature: 133.8°C
Minimum Temperature: 33.6°C
Differential Temperature: 113.0°C
Probable Cause: Loose / dirty connection

Recommended Action: Clean Connection and torque to proper specifications.

Replace top fuse clip as needed.

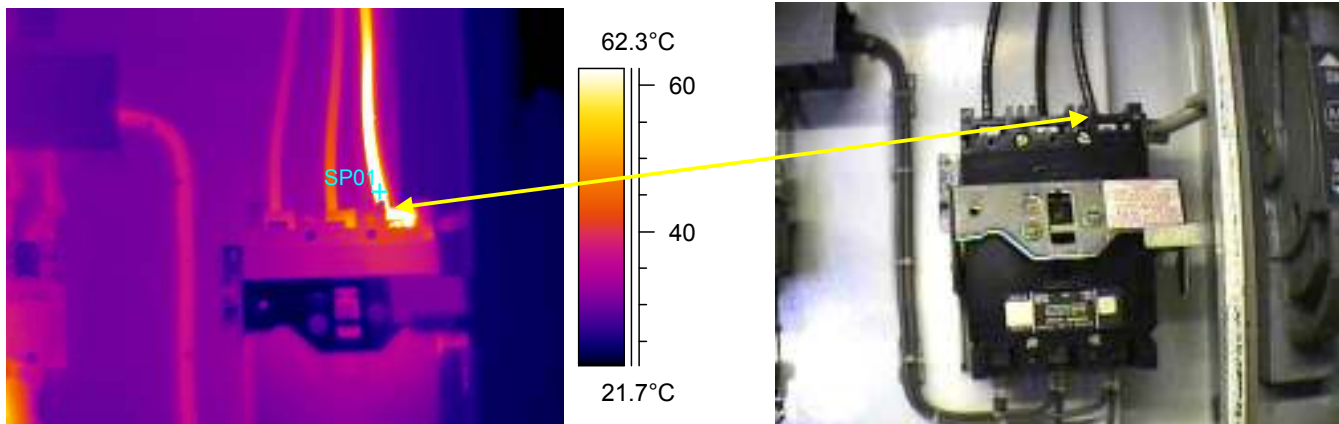
Date: 5/28/2002
Time: 9:15:21 AM
IR Scan Image File: C0528-25.img
Location: Air Makeup CC
Equipment: 40 Amp Main Breaker
Component: Right Line side cable connection
Maximum Temperature: 91.5°C
Minimum Temperature: 20.6°C
Differential Temperature: 70.7°C
Probable Cause: Loose / dirty connection

Recommended Action: Clean Connection and torque to proper specifications.

Clean cable connection and lug, using compound re-assemble and toqure to proper specifications.

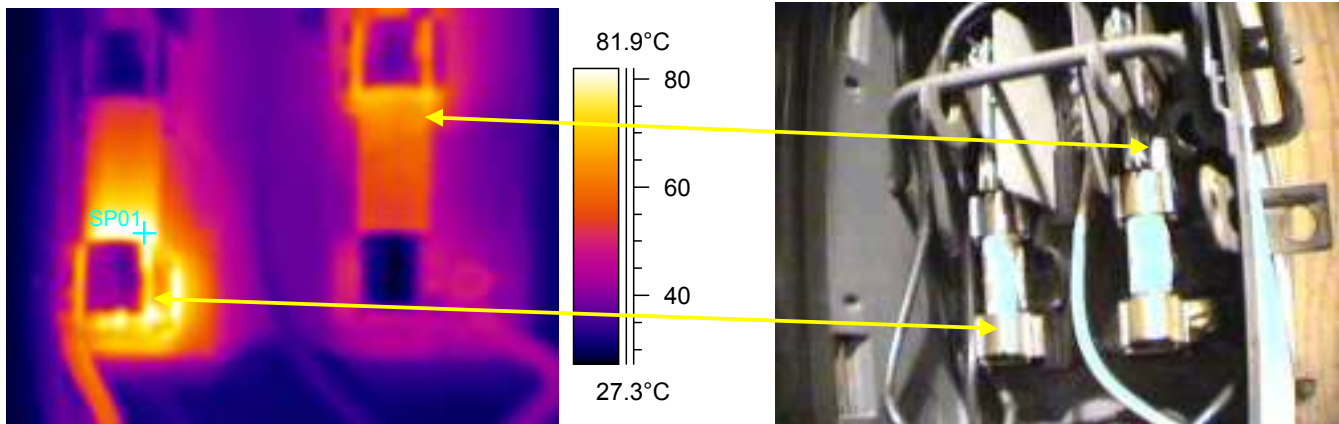
Date: 5/28/2002
Time: 9:52:09 AM
IR Scan Image File: C0528-27.img
Location: Boiler Room
Equipment: Cooling Tower Disc
Component: Fuse Clip lower left & top right
Maximum Temperature: 88.2°C
Minimum Temperature: 26.0°C
Differential Temperature: 67.4°C
Probable Cause: Loose / dirty connection

Boiler Room	Cooling Tower Disc	88.2°C	67.4°C	<i>Critical</i>

Recommended Action: Clean Connection and torque to proper specifications.

Clean all fuse clips or replace as needed both right and left.
